ES_N32WB03x Series Errata Sheet

Errata Sheet

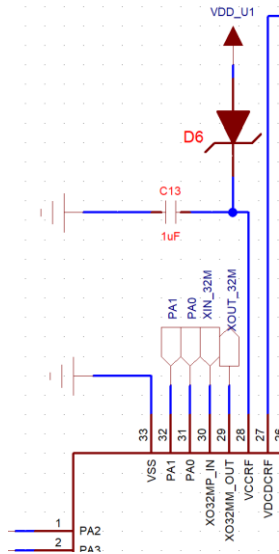
2.3 LSI issue affects wake-up.

For chip version B and C, when the power supply VCCRF is over 3V, there is risk of LSI, which will lead to abnormal wake-up of the Bluetooth protocol stack.

Ensure that the power supply VCCRF is lower than 3V. We recommend that VCC be connected to VCCRF after a diode to reduce the voltage, as shown in the following reference figure. The recommended diode models are BAV21W, BZT52C3V6 and BAP1321.
