ES_N32WB03x Series Errata Sheet

Errata Sheet

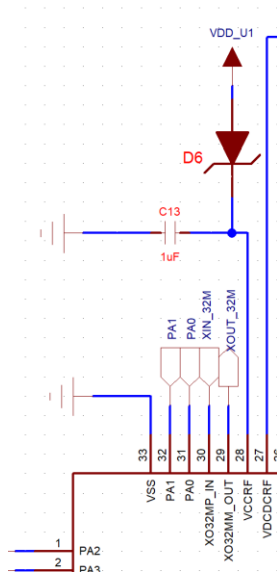
2.3. LSI issue affects wake-up.

For chip version B and C, when the power supply VCCRF is over 3V, there is risk of LSI, which will lead to abnormal wake-up of the Bluetooth protocol stack.

Ensure that the power supply VCCRF is lower than 3V. We recommend that VCC be connected to VCCRF after a diode to reduce the voltage, as shown in the following reference figure. The recommended diode models are BAV21W, BZT52C3V6 and BAP1321.
