# **N32G430 Series**

## **Errata Sheet**

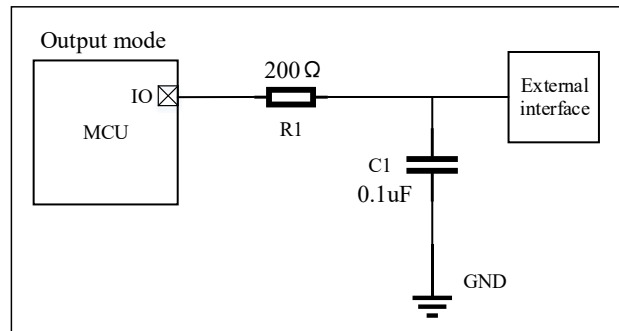
### 6.1 Glitches Occur on the IO during Chip Power-on

When the MCU is powered on, some IOs will have glitches appeared.

When IO is used as an input, glitches have no effect on the MCU; When IO is used as an output, an external 200Ohm resistor and a 0.1uF capacitor are applied for filtering to solve the issue.
