# N32G401 Series Errata Sheet

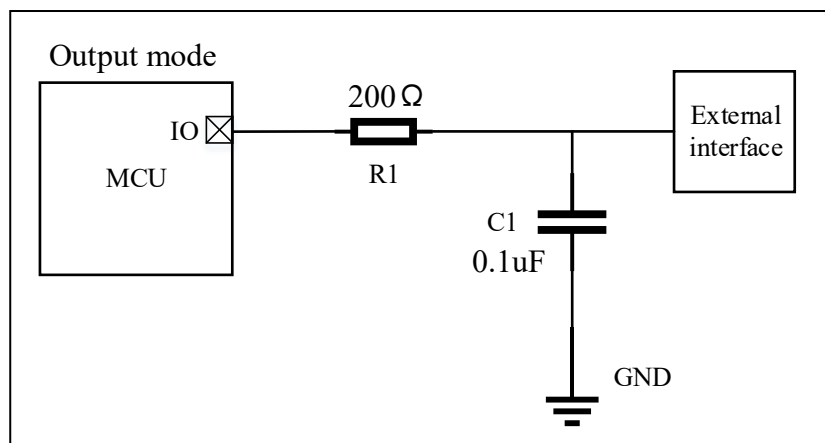
When the MCU is powered on, some IOs will have glitches appeared.

When an IO is used as an input, the glitches have no effect on MCU; When an IO is used as an output, an external 200Ohm resistor and a 0.1uF capacitor are applied for filtering to solve the issue.
