N32G401 Series Errata Sheet

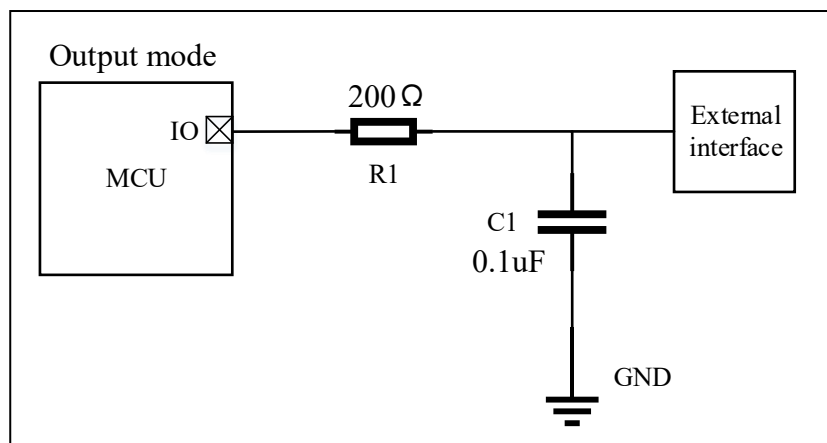
When the MCU is powered on, some IOs will have glitches appeared.

When an IO is used as an input, the glitches have no effect on MCU; When an IO is used as an output, an external 200Ohm resistor and a 0.1uF capacitor are applied for filtering to solve the issue.
