# N32H47x\_48x Series Errata Sheet V0.7.0

# 1 Errata List

Table 1-1 Overview of Errata

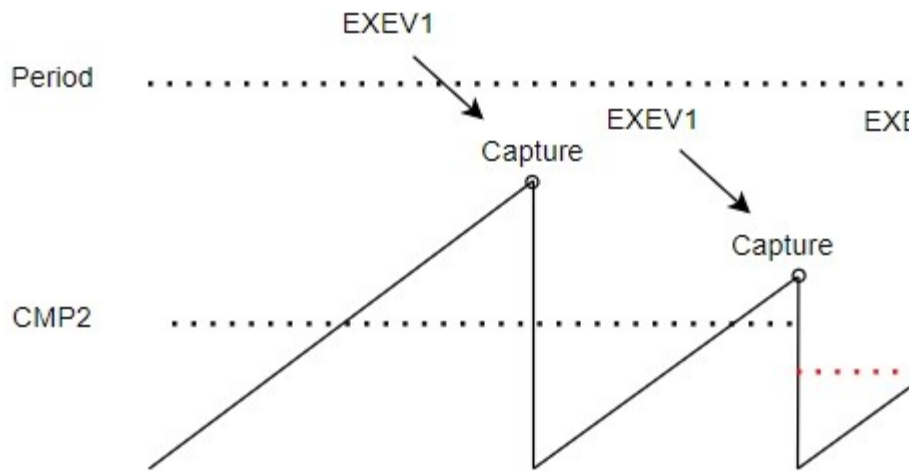
Correct:

In the half-trigger mode, when a capture event occurs, the counter is not reset, and the CMP2 is updated to half of the captured value.

None

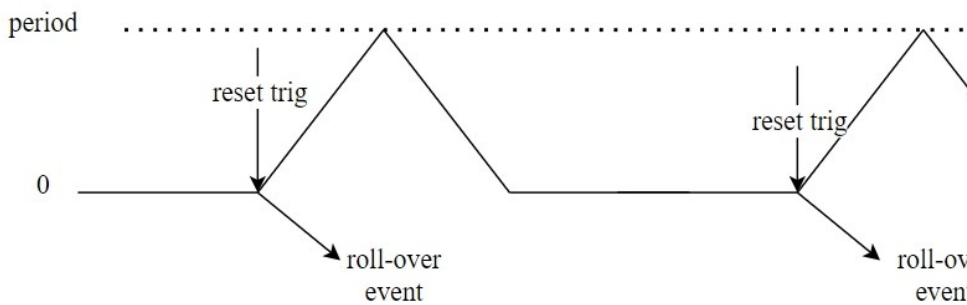
Correct:

In up/down single mode, the rollover event occurs when the counter resets or flips to 0. However, in reality, it occurs when counting to the period value. As shown in the following figure.

<b>Workaround</b> None		
	Issue with external event window in up/down mode		
	Workaround None	•	•
	<b>Error! Reference source not found.</b>	•	•
	Issue with periodic event triggering ADC	•	Modify
	In greater than mode, preload function of all registers is disabled	•	Modify
	Delayed idle cannot be enabled before the first output enable	•	•
	Issue with IDLE state transitioning to FAULT state	•	Modify
	External fault source is still valid, and the fault flag can be cleared		
	When the fault is not restored, the FAULT flag cannot be set while the second fault signal is valid		
TIM	<b>Error! Reference source not found.</b>	•	•
U(S)ART	Issue with inability to send data properly in 485+DMA mode	•	Modify
ADC	Issue with multiple ADCs operating in synchronous regular and alternate mode with oversampling and reset mode enabled	•	Modify
USB	<b>Error! Reference source not found.</b>	•	•
SPI	Issue with SPI receives FIFO underflow flag	•	Modify

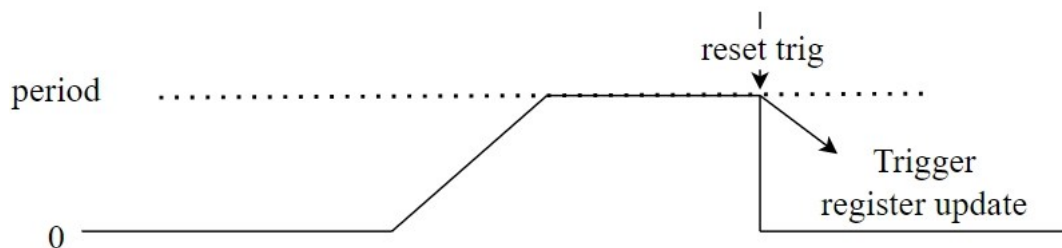
Correct:

When preload is enabled, SHRTIM\_TxCTRL.RSTROUEN is enabled, and the TIMx counter resets or flips to 0, triggering register update. However, in reality, the register update is triggered when the counter counts to the period value.

If it is in continuous counting mode, this issue does not affect the usage. If it is in single-count mode, this issue will affect the usage. As shown in the following figure.

None

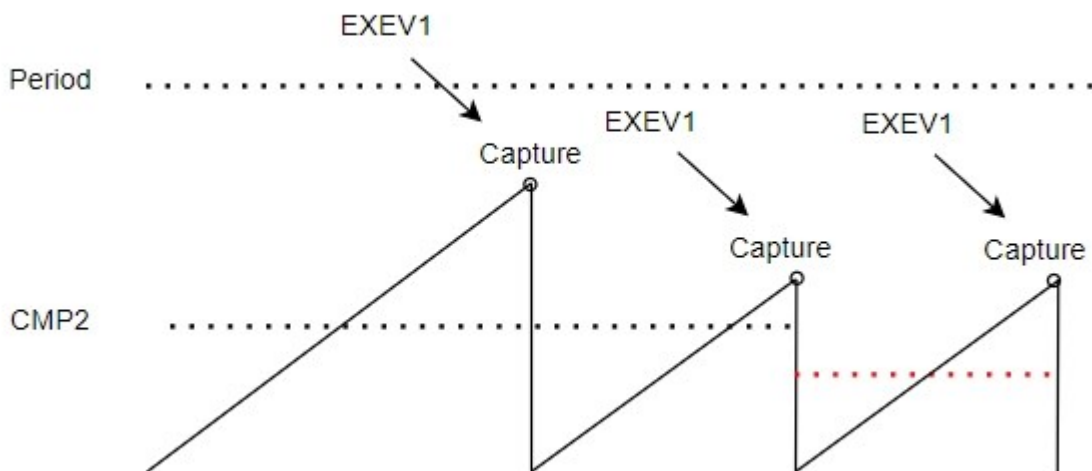
Correct:

In the half-trigger mode, when a capture event occurs, the counter is not reset, and the CMP2 is updated to half of the captured value.

None

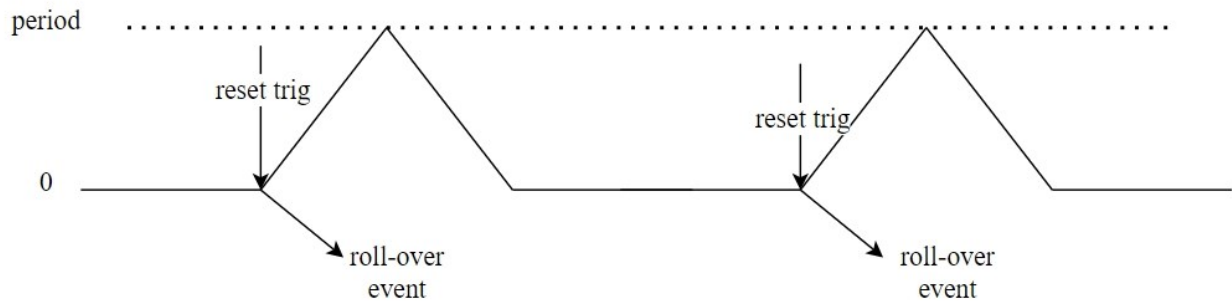
Correct:

In up/down single mode, the rollover event occurs when the counter resets or flips to 0. However, in reality, it occurs when counting to the period value. As shown in the following figure.

None

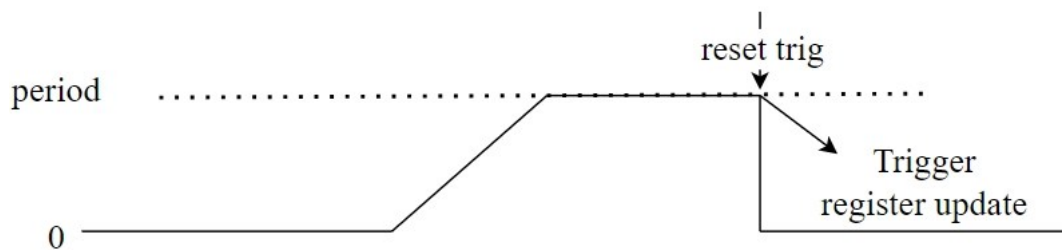
Correct:

When preload is enabled, SHRTIM\_TxCTRL.RSTROUEN is enabled, and the TIMx counter resets or flips to 0, triggering register update. However, in reality, the register update is triggered when the counter counts to the period value.

If it is in continuous counting mode, this issue does not affect the usage. If it is in single-count mode, this issue will affect the usage. As shown in the following figure.

None

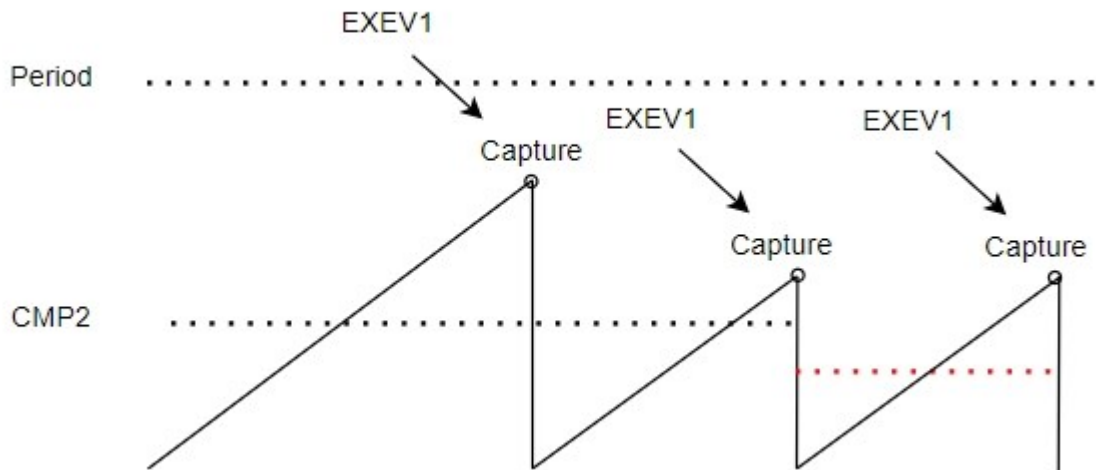
Correct:

In the half-trigger mode, when a capture event occurs, the counter is not reset, and the CMP2 is updated to half of the captured value.

None

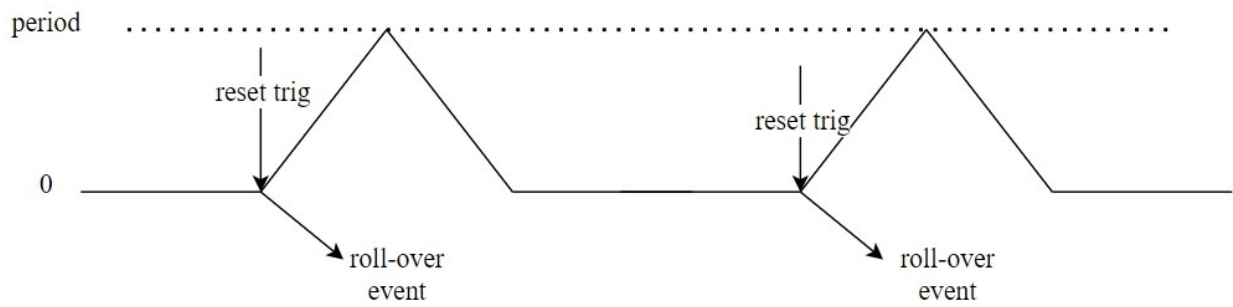
Correct:

In up/down single mode, the rollover event occurs when the counter resets or flips to 0. However, in reality, it occurs when counting to the period value. As shown in the following figure.

None

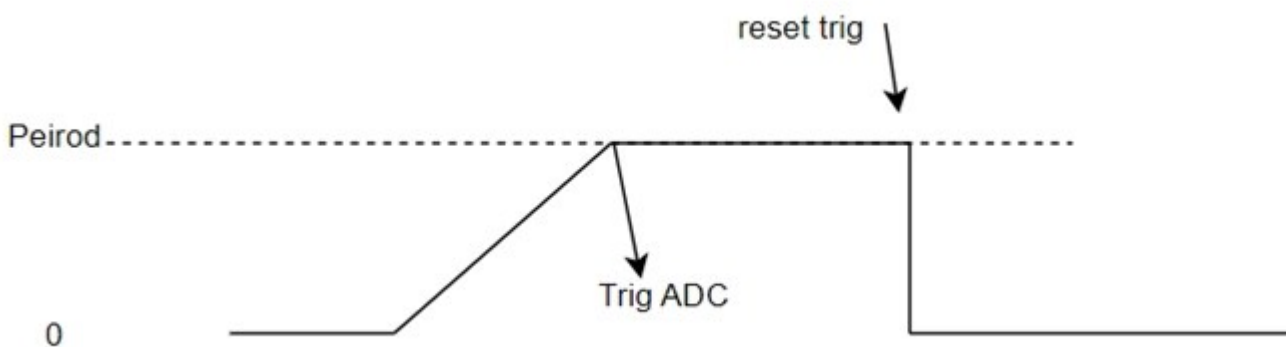
Correct:

When the periodic event is used for ADC triggering, the trigger signal should be generated when the counter counts to the period value. However, in reality, the trigger signal is generated only when the counter value flips from the period value to zero.

If it is in continuous counting mode, this issue does not affect the usage. If it is in single-count mode, this issue will affect the usage. As shown in the following figure.

Use another trigger source (such as CMP5) instead of the periodic trigger.
